BUREAU OF SHIPS GROUP TECHNICAL INSPECTION REPORT

OPERATION CROSSROADS. U.S.S. INDEPENDENCE (CVL22)

TEST ABLE

VOLUME 1 OF 4 [U].

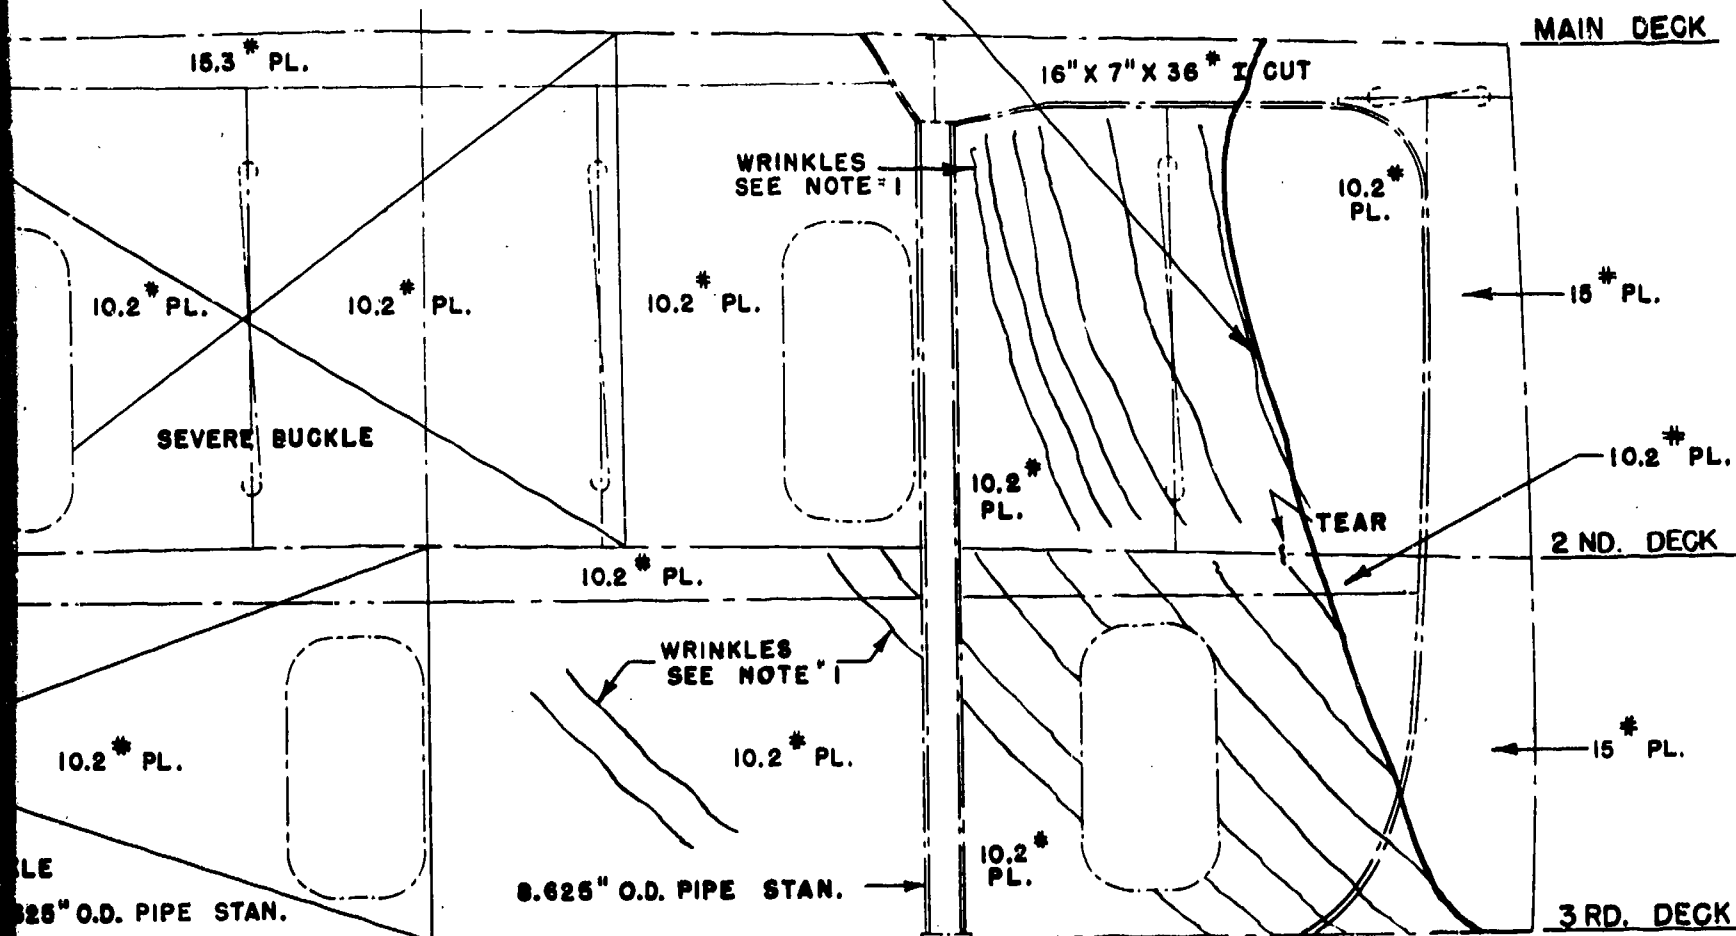
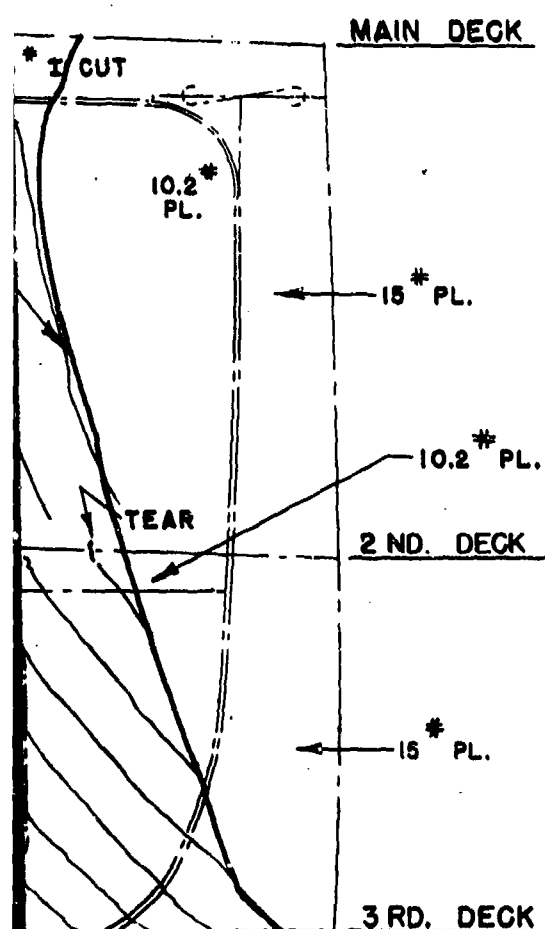
TRANSV. W.T. BHD. 144
LOOKING AFT.

1. NO. OF LINES INDICATES DEPTH OF WRINKLE IN PLATING (INCHES).
2. NO DATA AVAILABLE REGARDING DECK DEFLECTION. SHELL DAMAGE INDICATED TAKEN FROM PHOTOS.

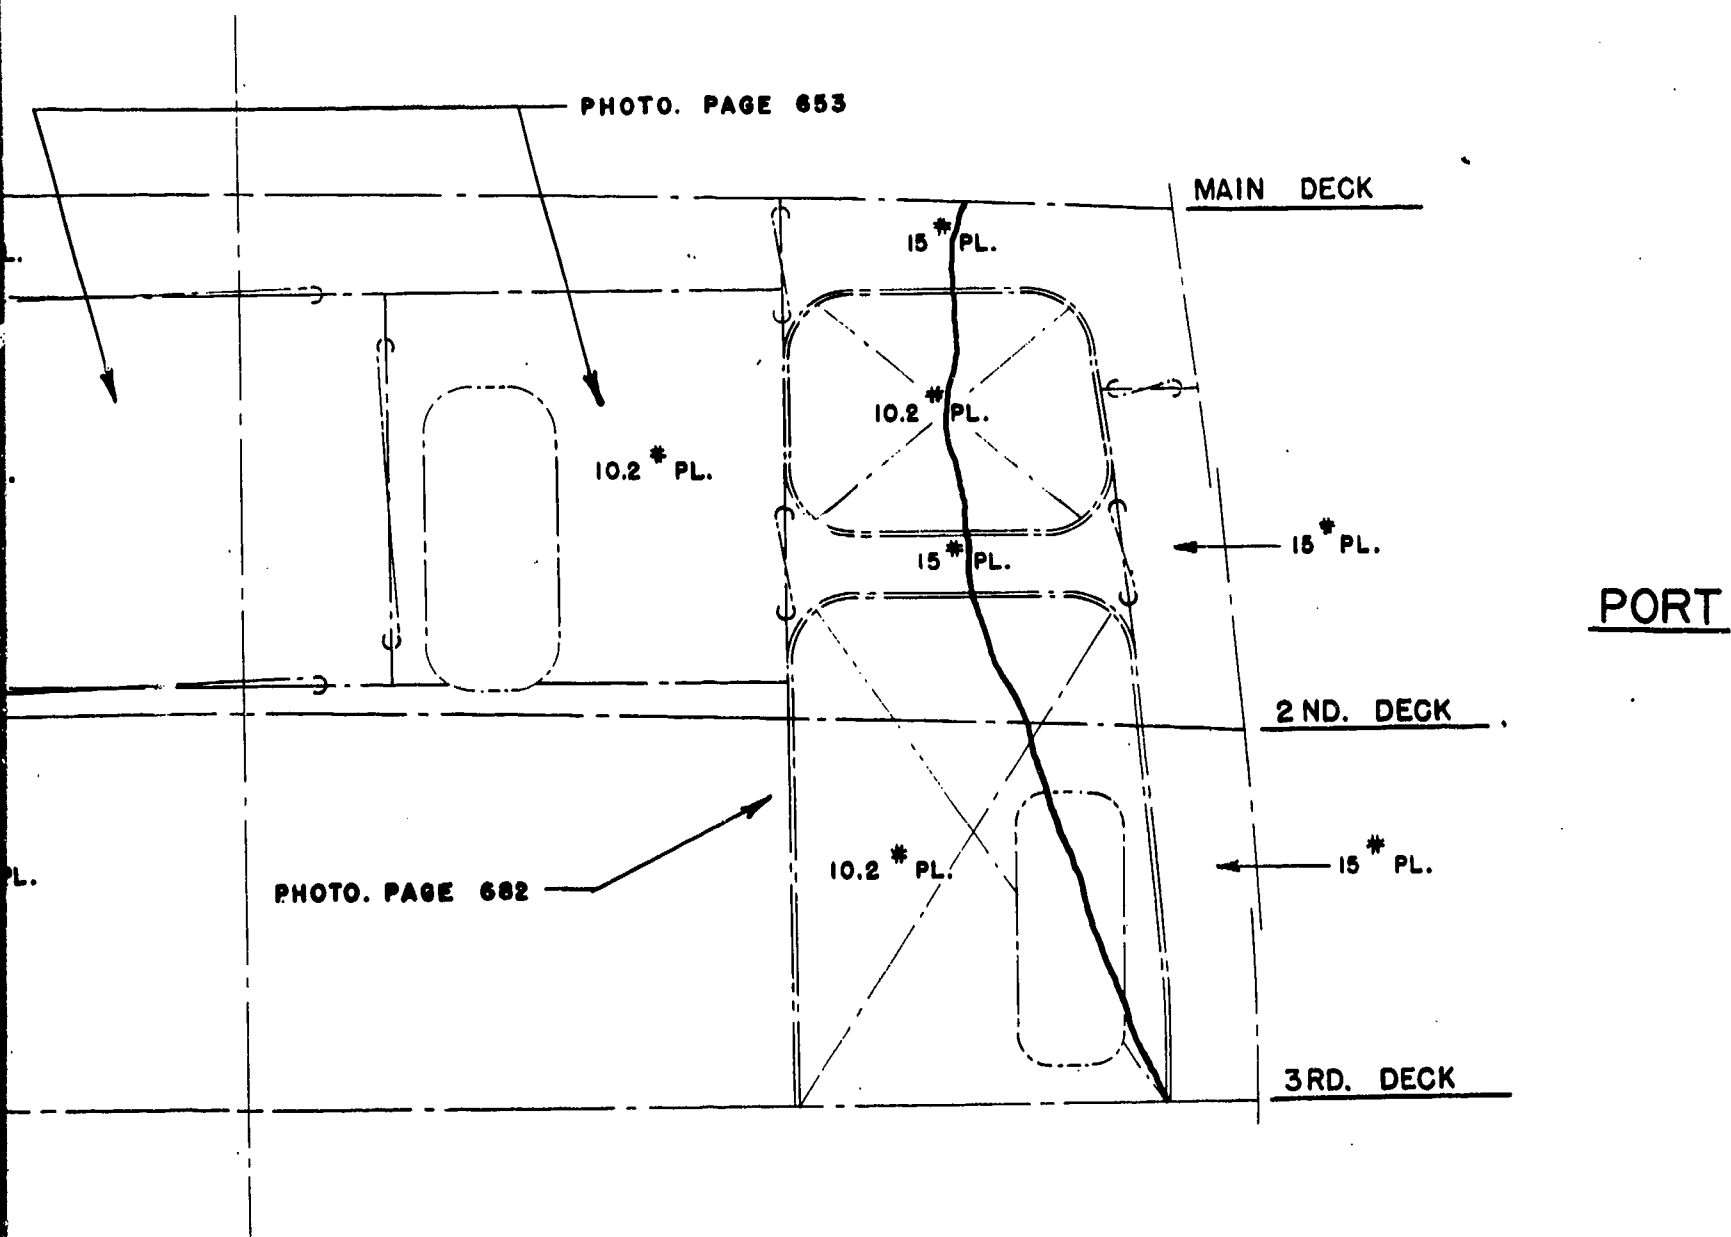
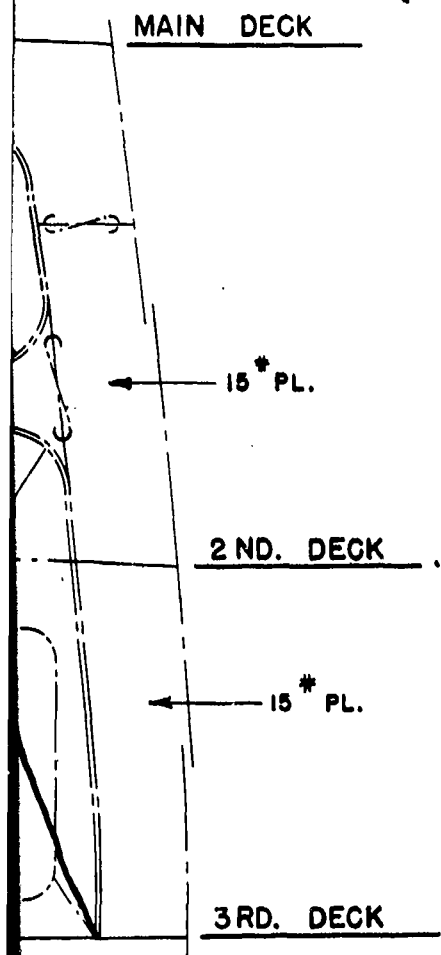
NO DATA AVAILABLE REGARDING DECK &
BULKHEAD DEFLECTION. SHELL DAMAGE
INDICATED TAKEN FROM PHOTOS.

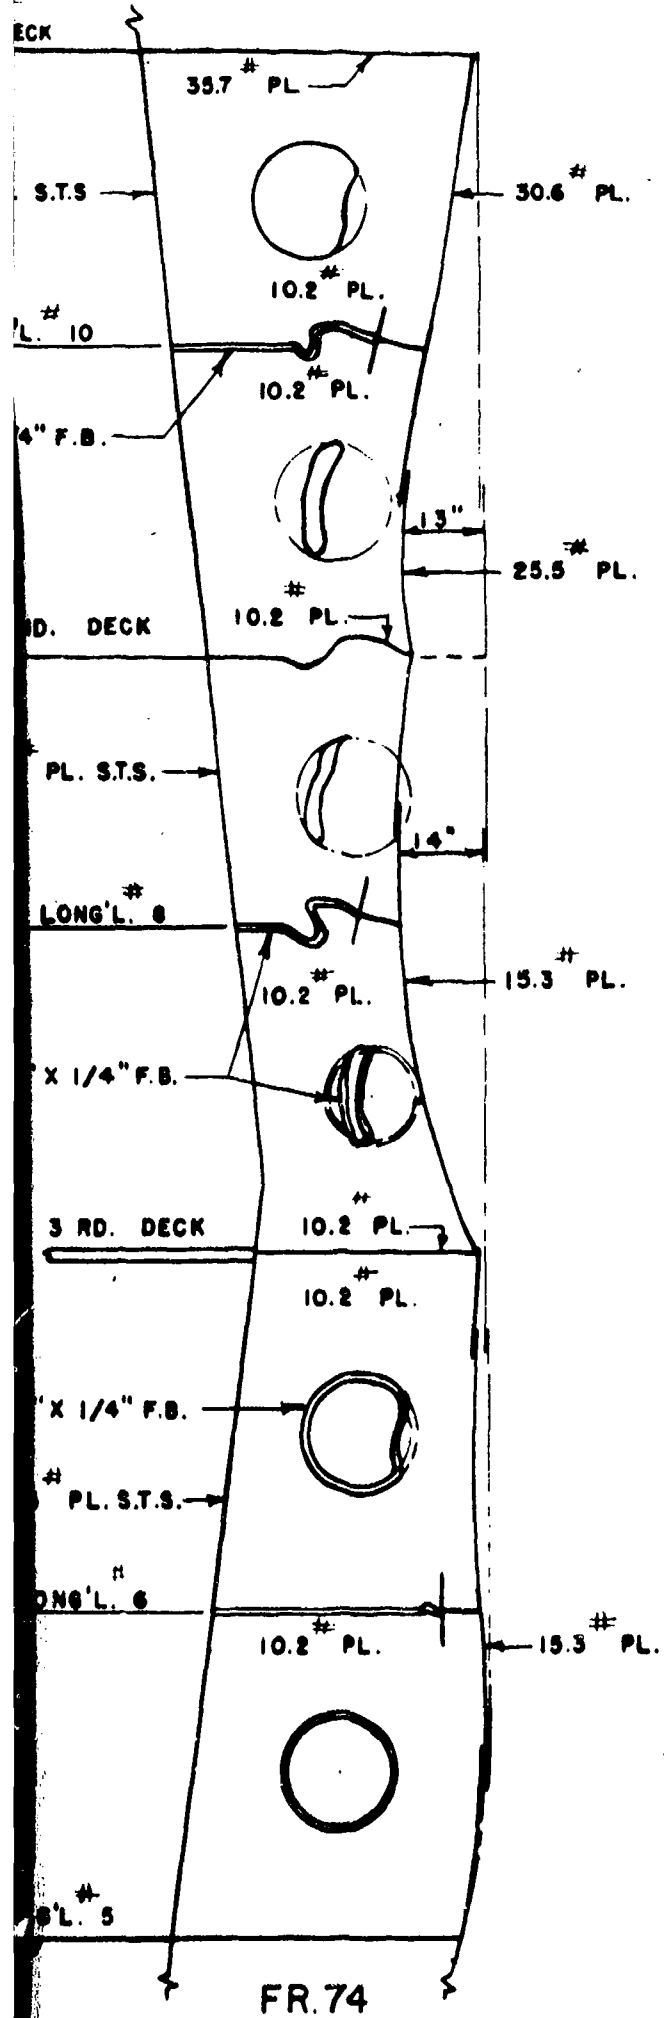
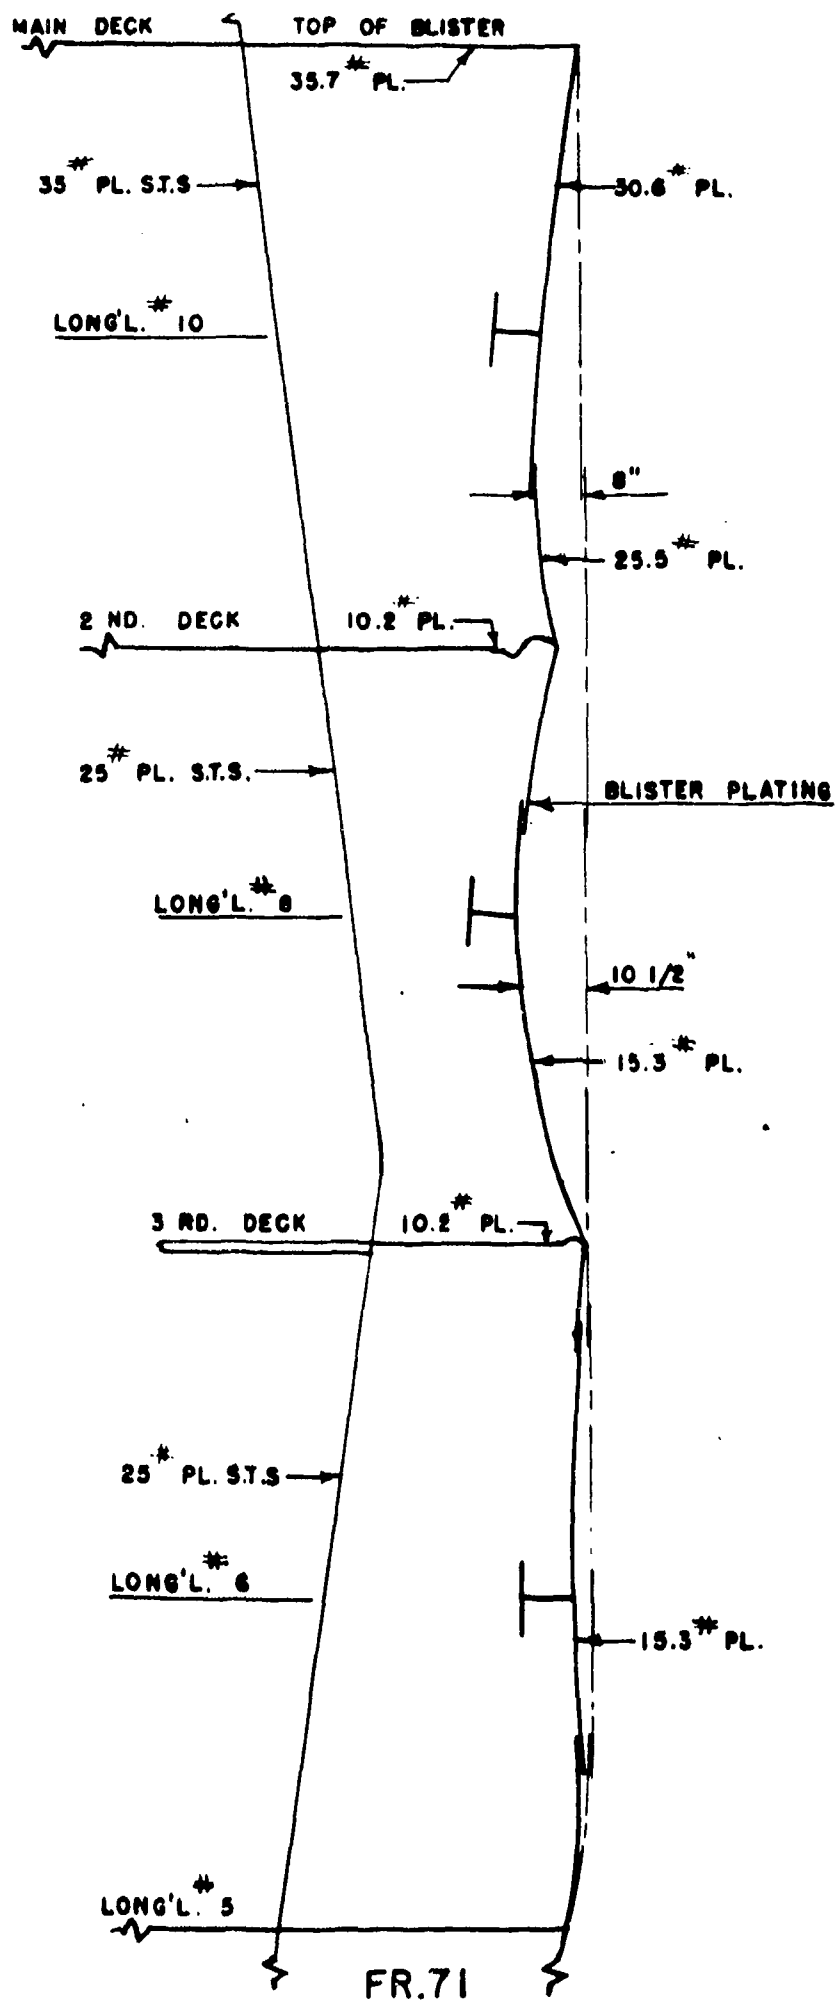
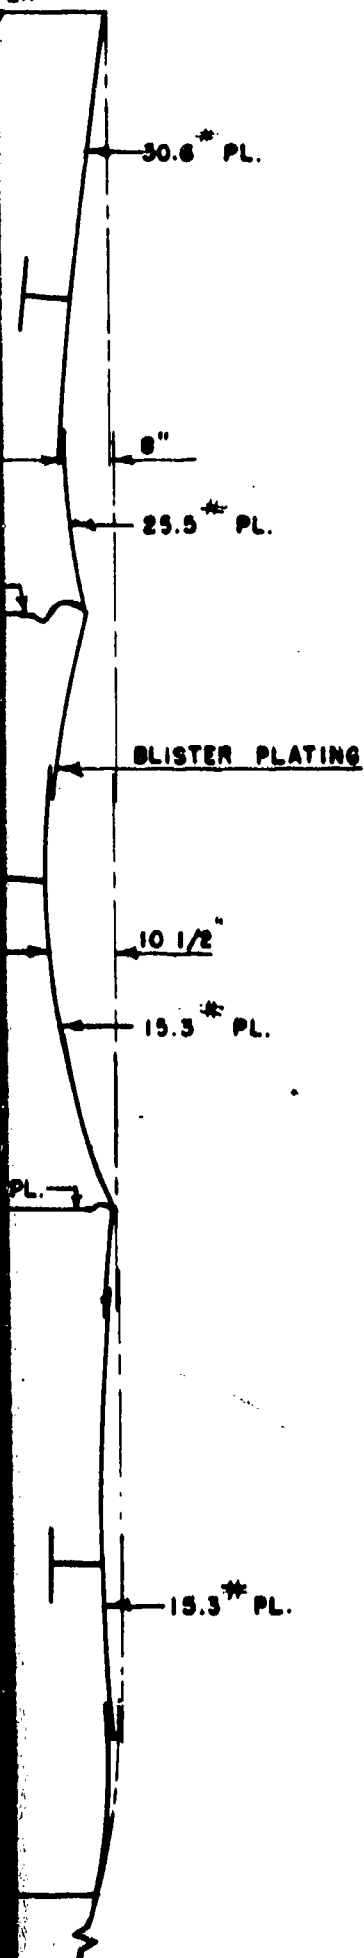
1. NO DATA AVAILABLE REGARDING DEFLECTION OF INNER SHELL PLATING.
2. ALL SECTIONS ARE SHOWN PORT SIDE LOOKING AFT.
3. FWD. OF FR. NO. 71 DEFLECTION DIMISHES TO " 0 " AT FR. 59, FWD. OF FR. 59 LIGHT WASH BOARD EFFECT.

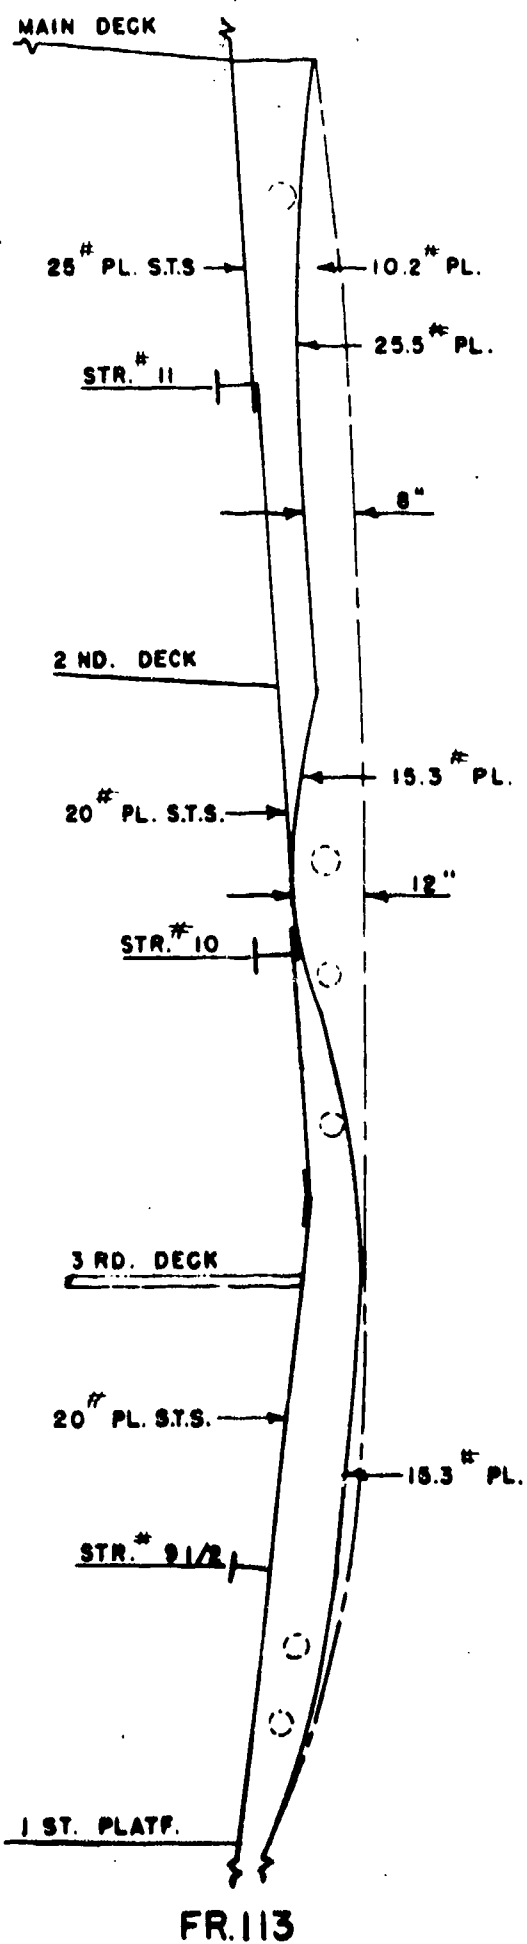
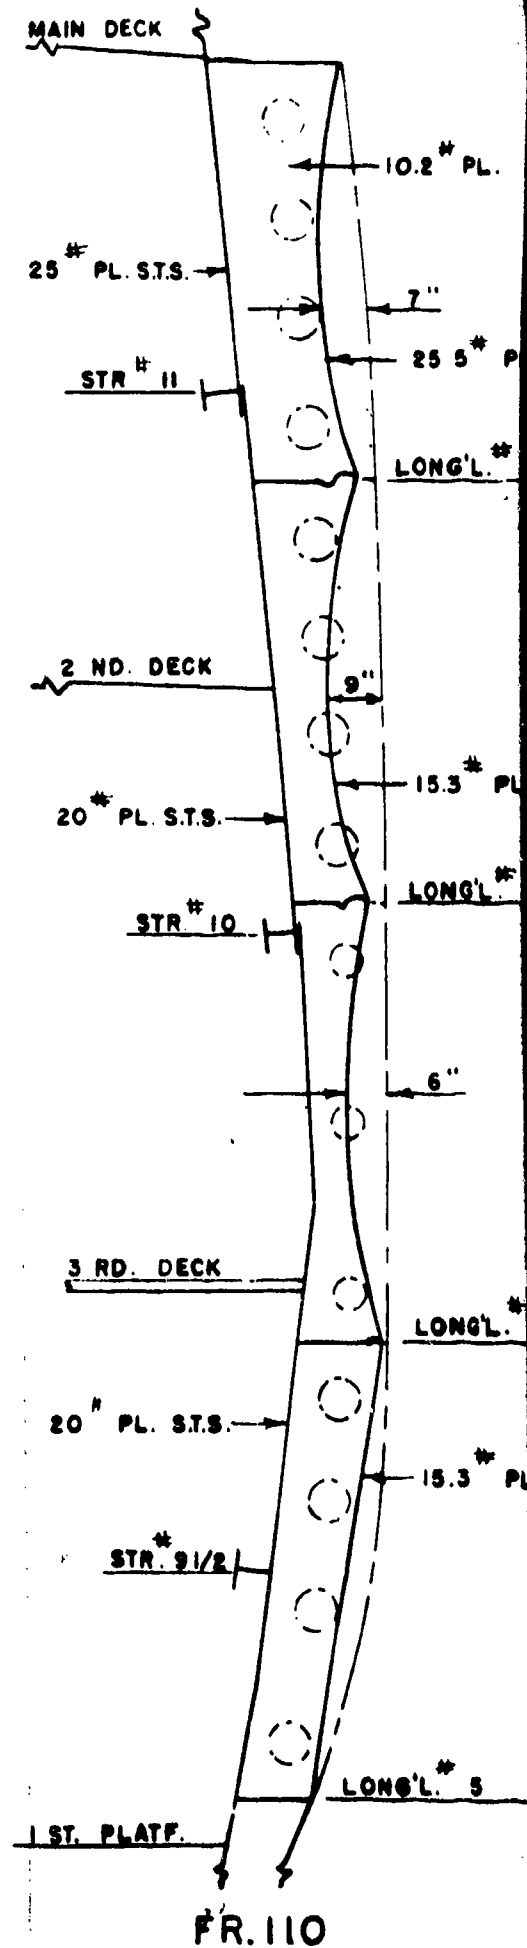
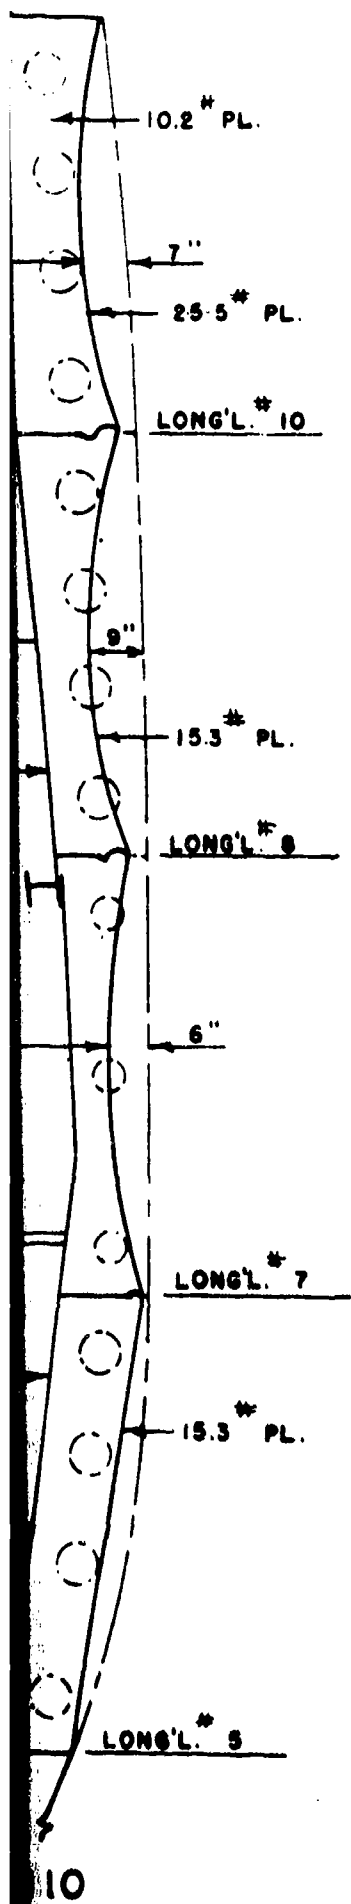
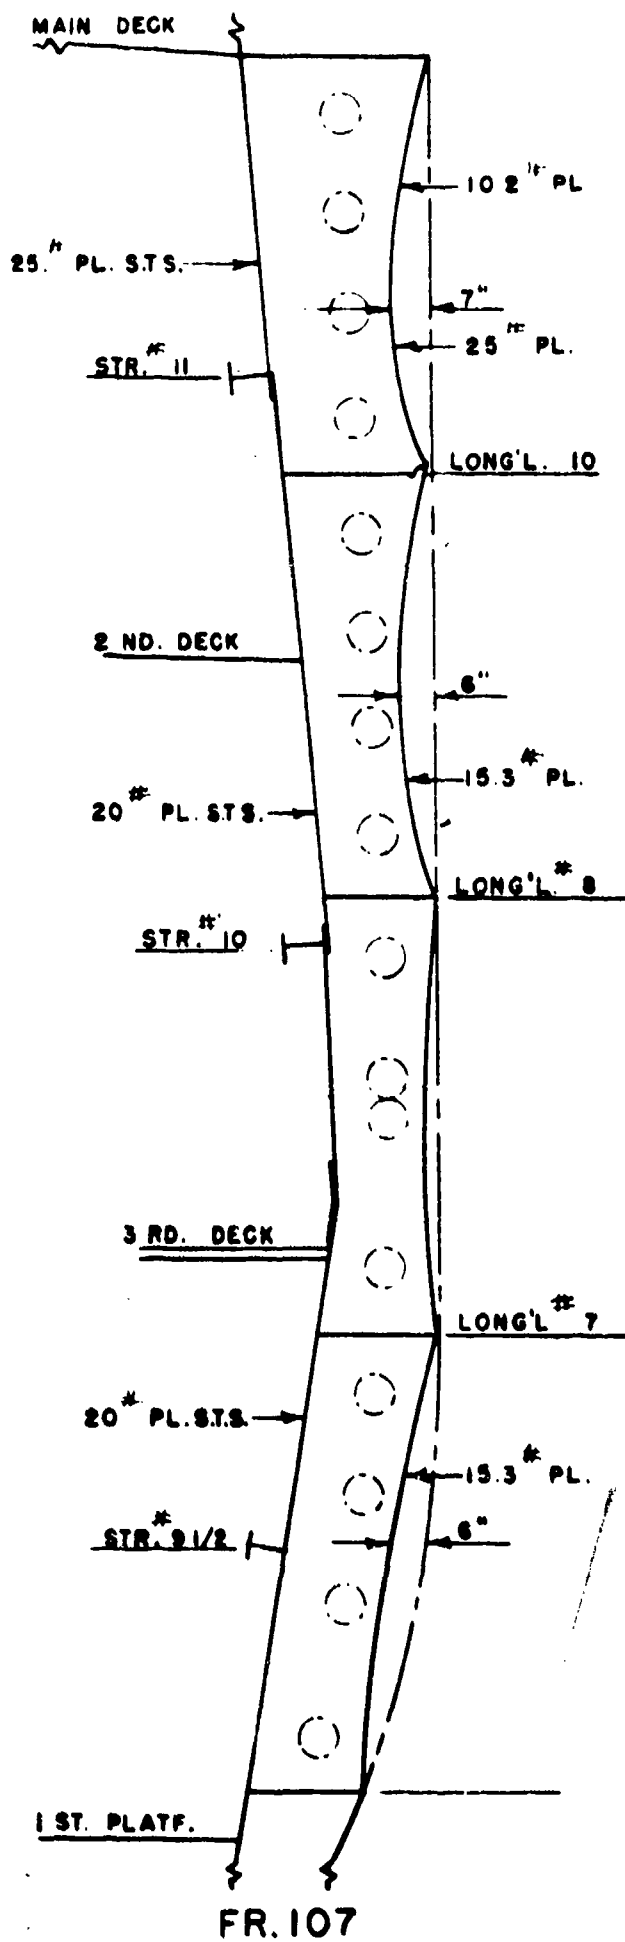
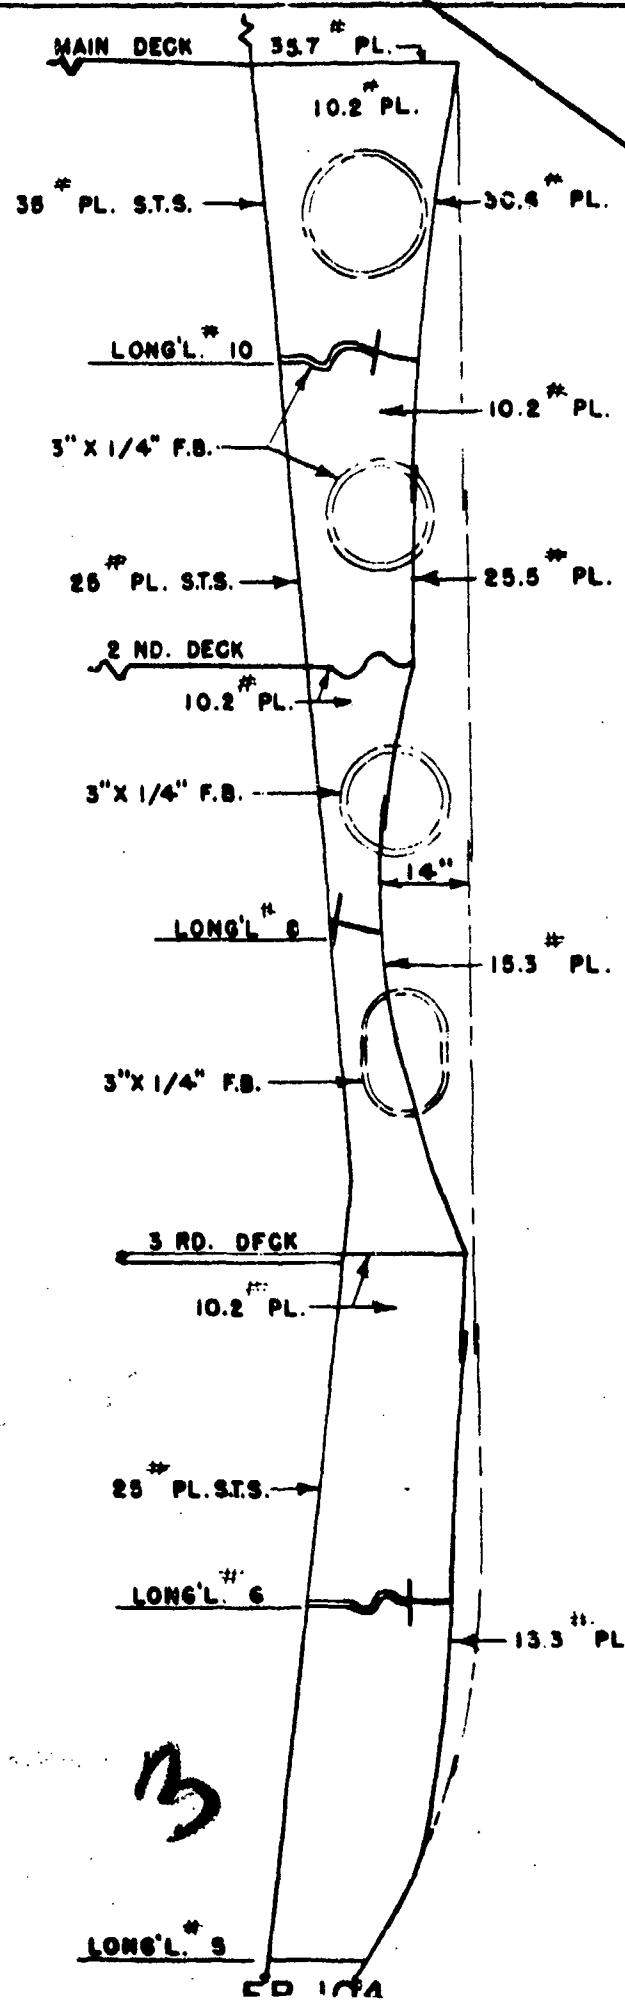
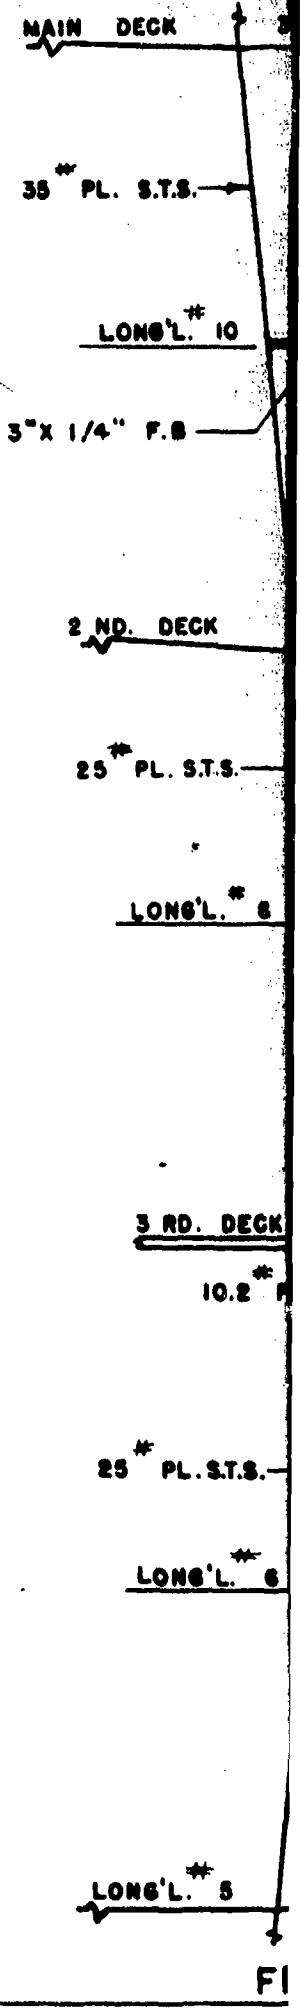
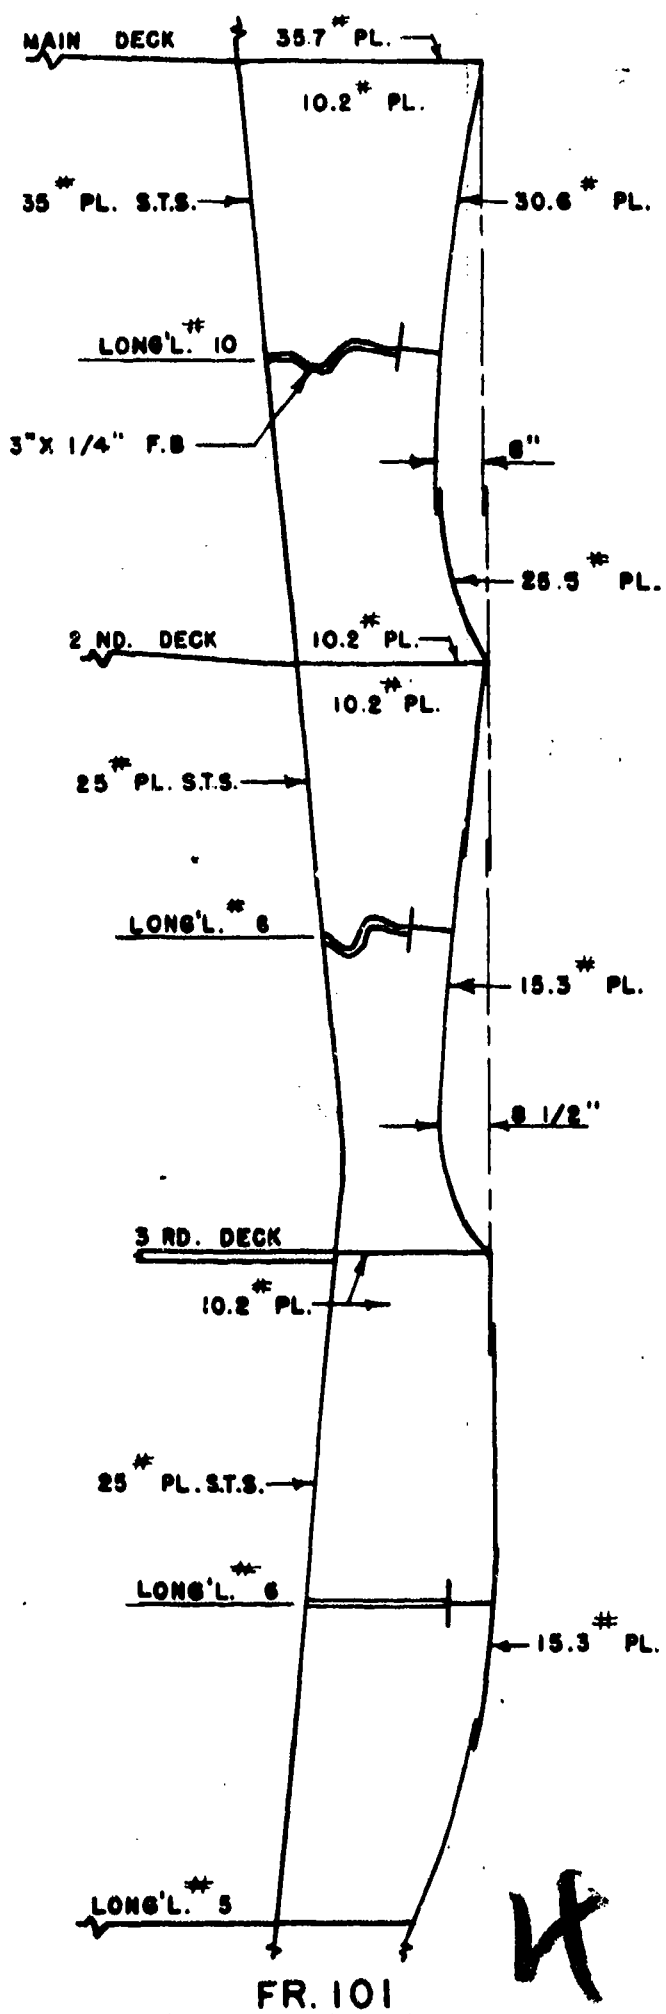
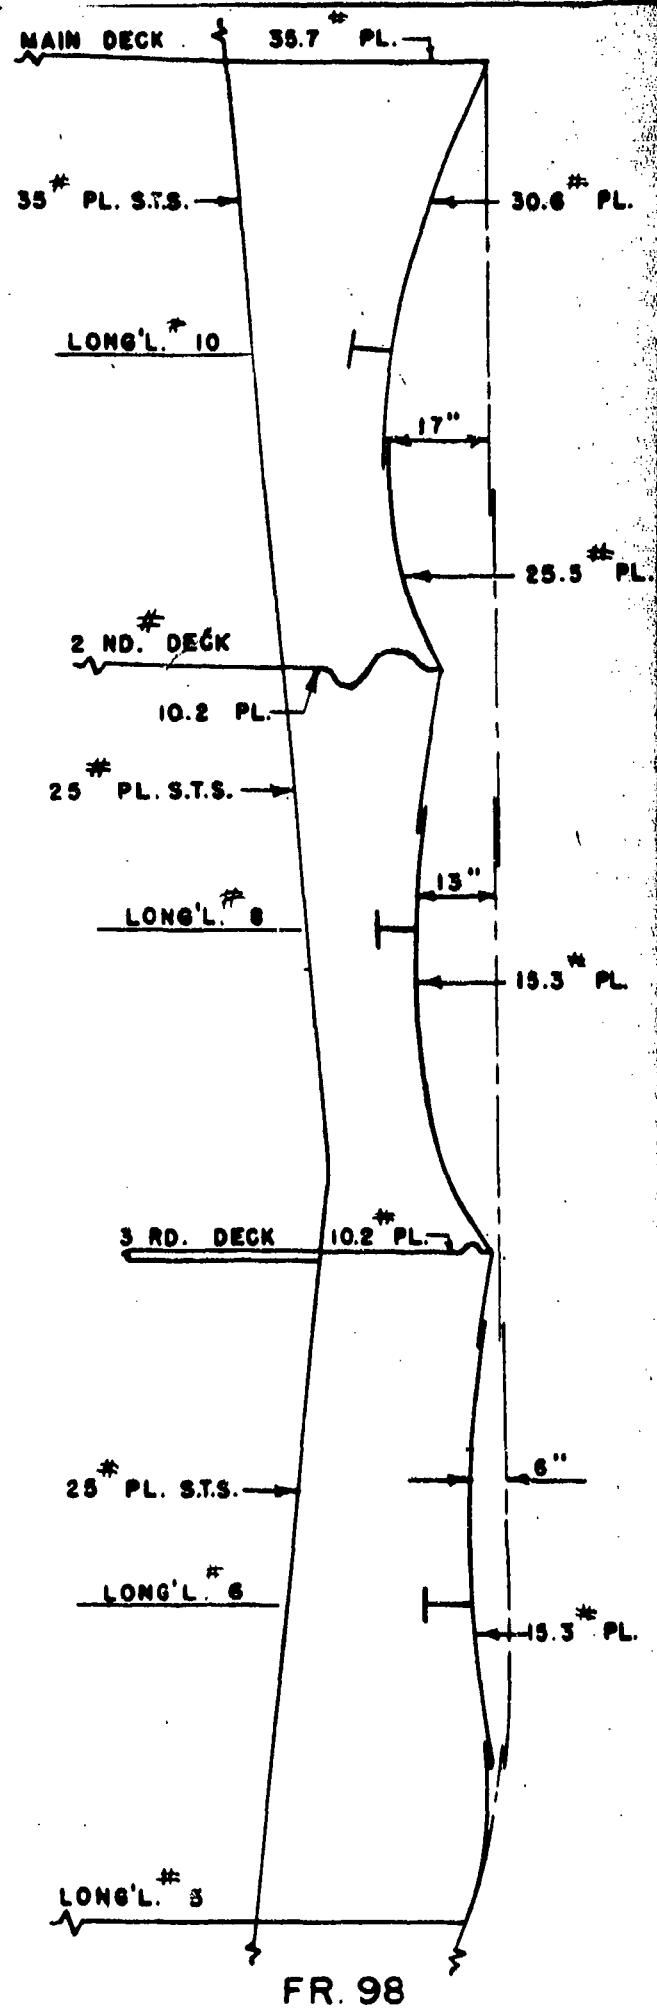
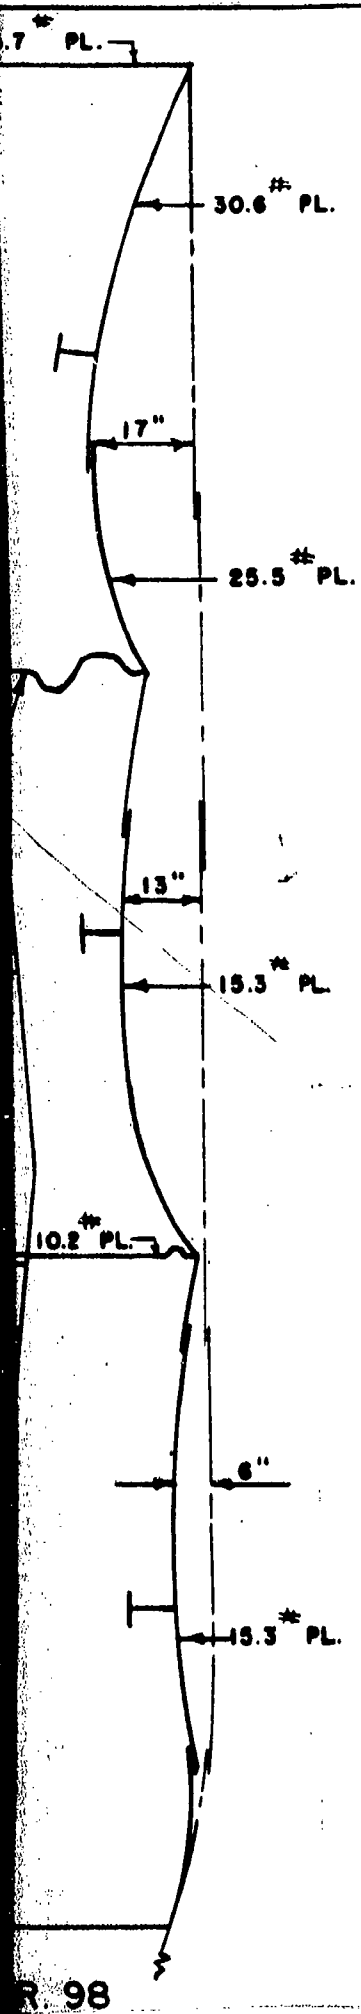
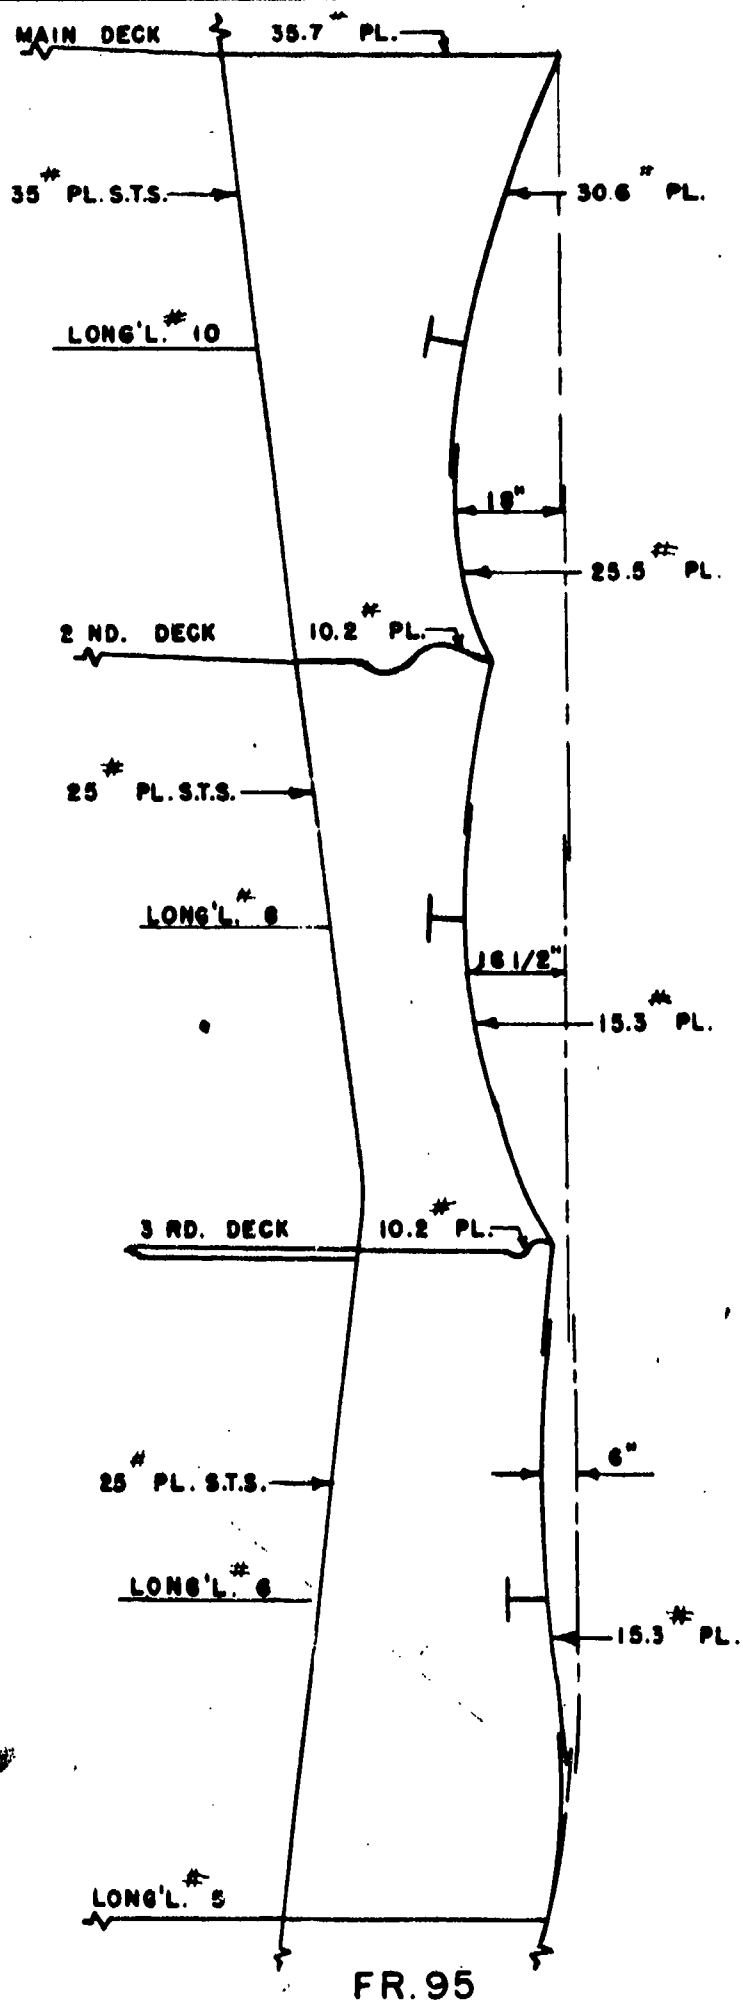
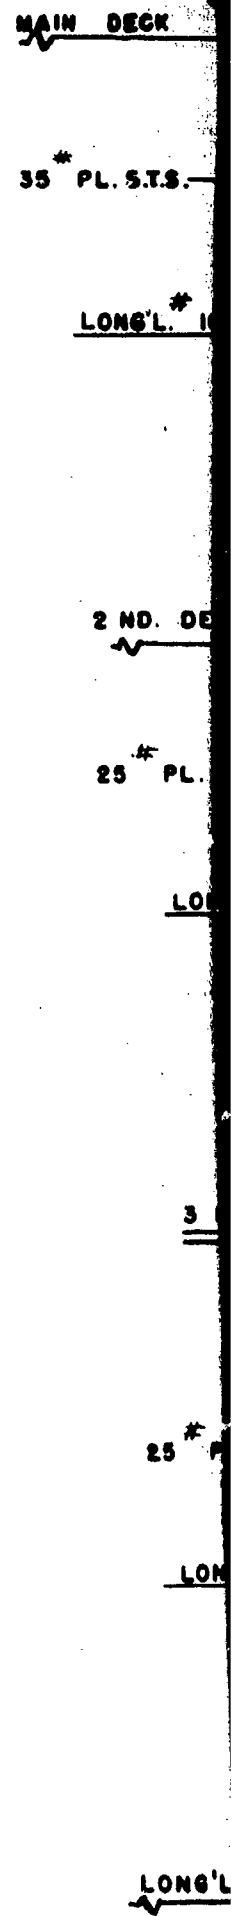
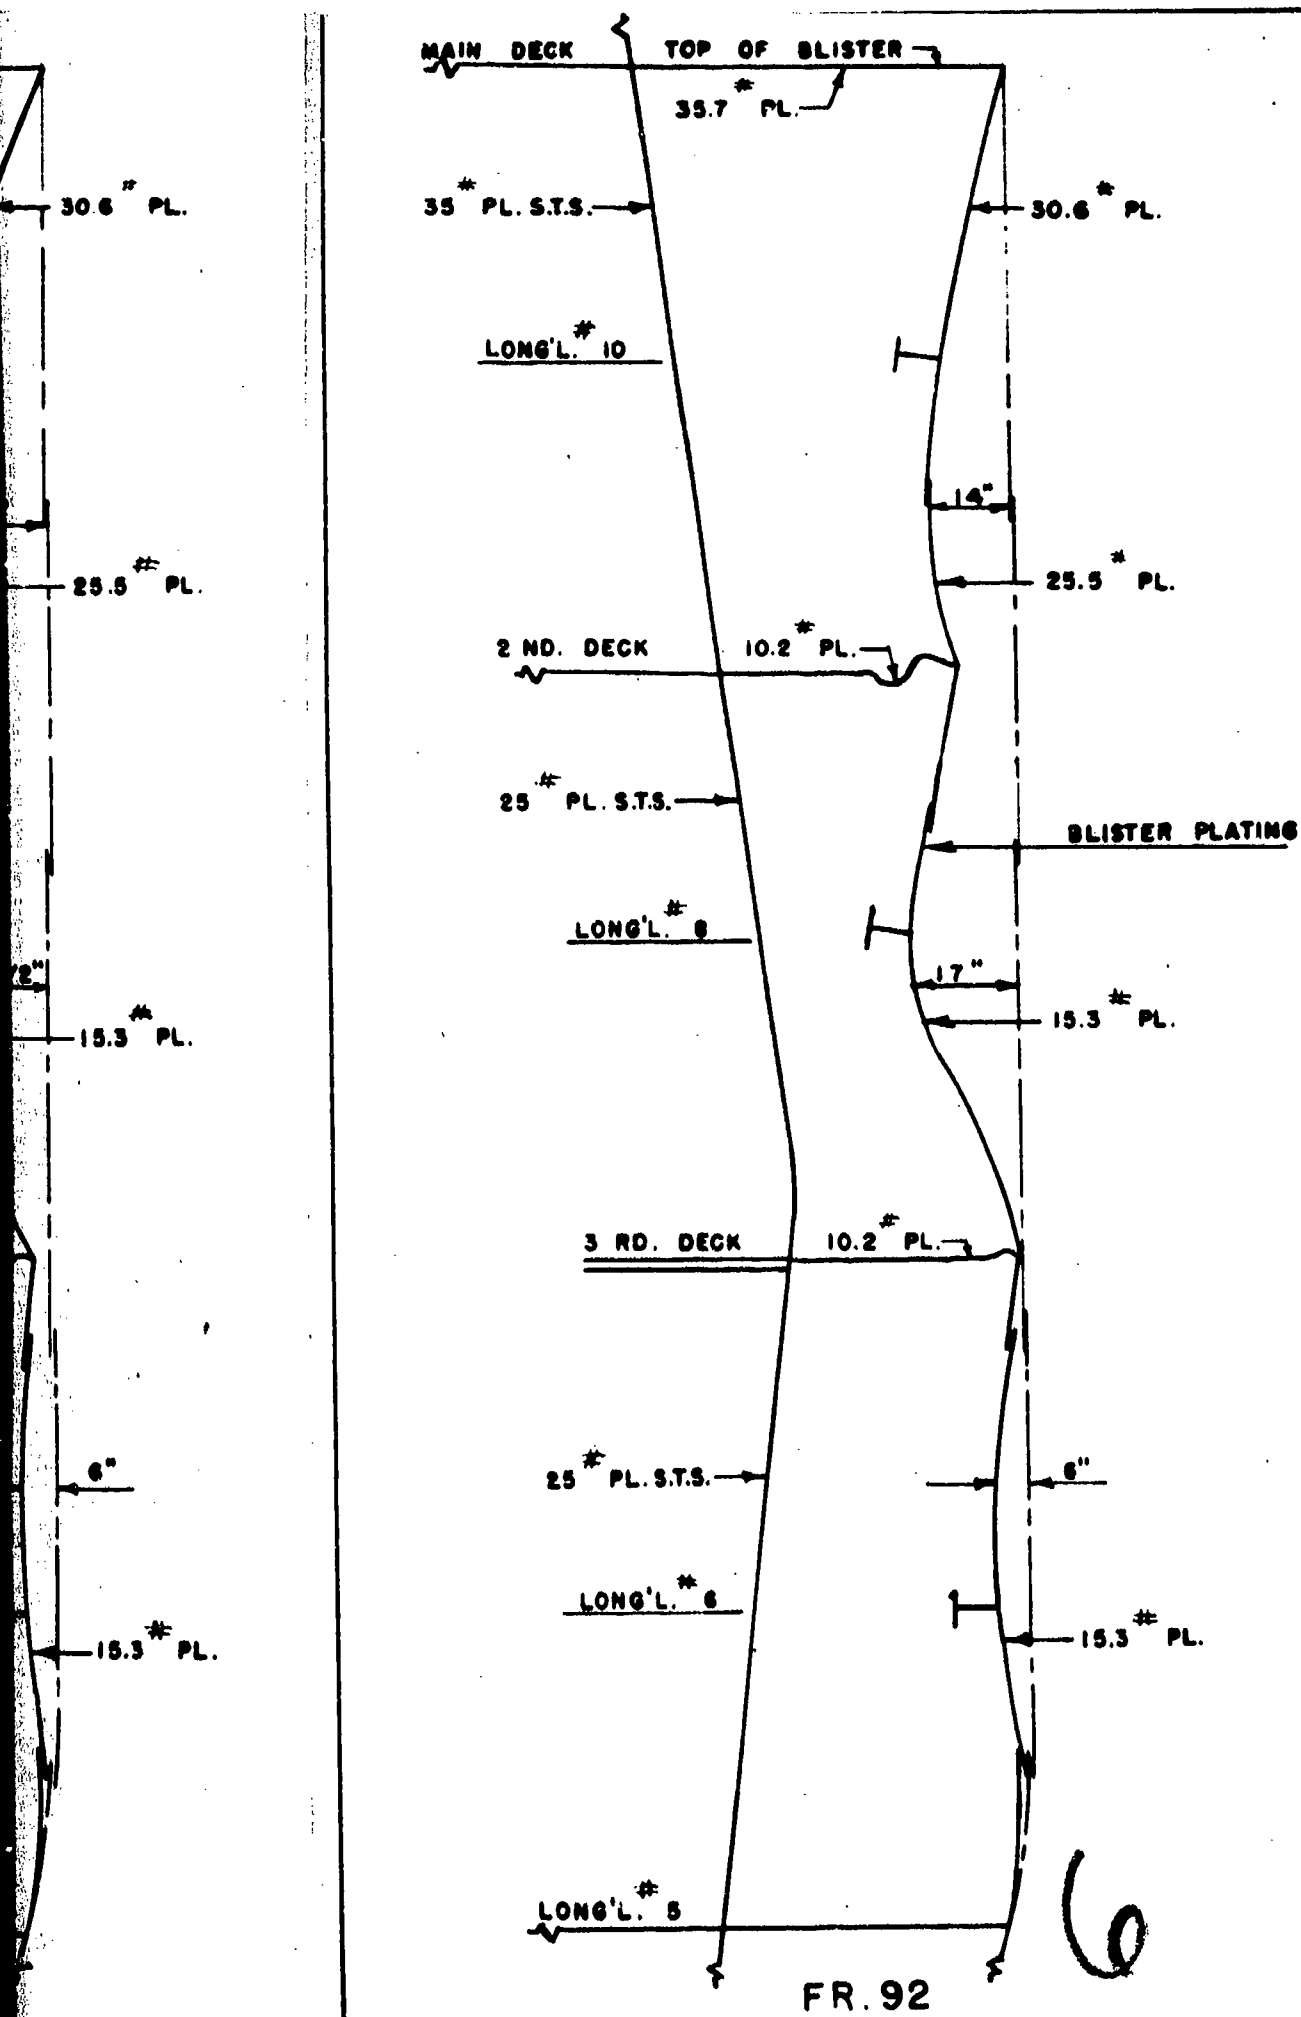
BLISTER DAMAGE
FRS.92-113, PORT SIDE

1. NO DATA AVAILABLE REGARDING DEFLECTION OF INNER SHELL PLATING.
2. ALL SECTIONS ARE SHOWN PORT SIDE LOOKING AFT.

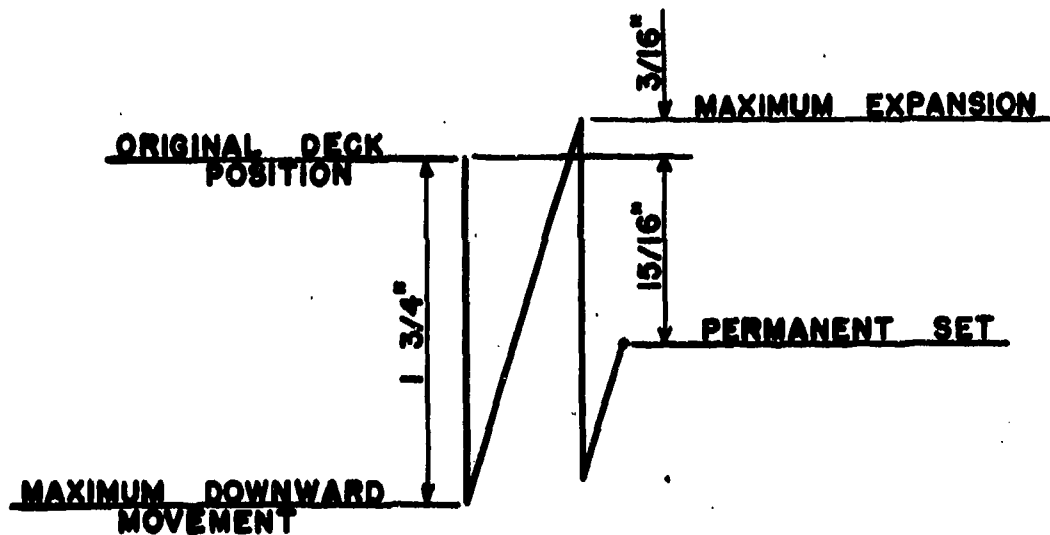
U.S.S. INDEPENDENCE, TEST ABLE, PLOT OF MAIN DECK
MOVEMENT. SCRATCH GAGE LOCATION, 2ND. DECK
FRAME 63 PORT 16'-0" OFF CENTER LINE.
